## DIAGNOSIS AND PROPOSAL FOR THE RESTORATION OF A TIMBER-FRAMED BUILDING AND ITS RESULTS APPLYING STATIC AND DYNAMIC TESTS

This communication presents the results of the tests carried out on a newly assessed and subsequently restored timber structure of a residential building in the city of Valladolid (Spain).

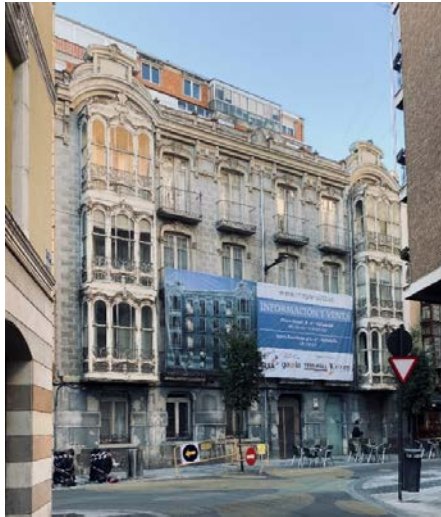
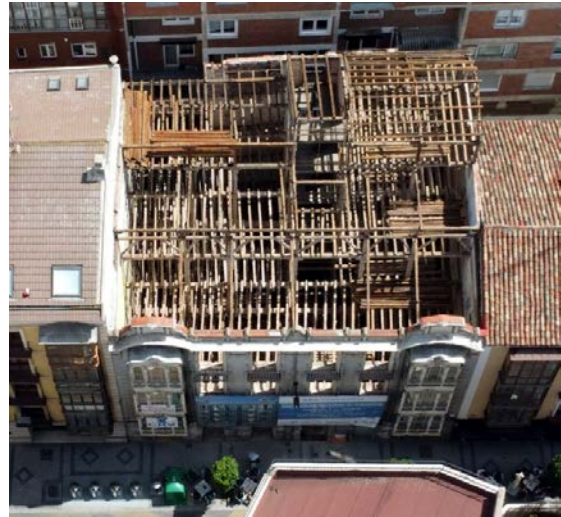
The building, which is approximately 100 years old, is located between party walls, in the historic center of the city of Valladolid. It has been used for residential purpose, but for several years it was abandoned and in a state of serious decay until it was finally acquired in 2019 by a real estate company with the aim of refurbishing it and putting it back on sale. (Figure 1: ).

Figure 1: Previous state of the building (2019).

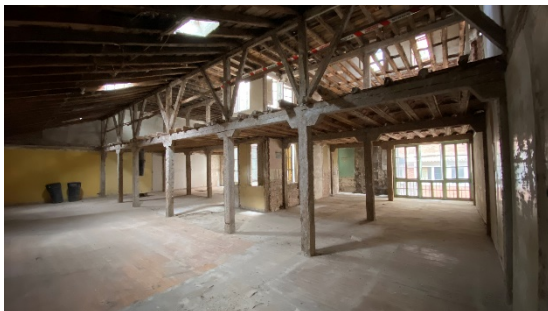
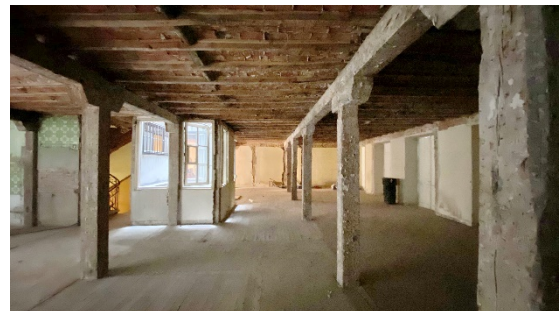
Figure 2: Timber structure (initial state).

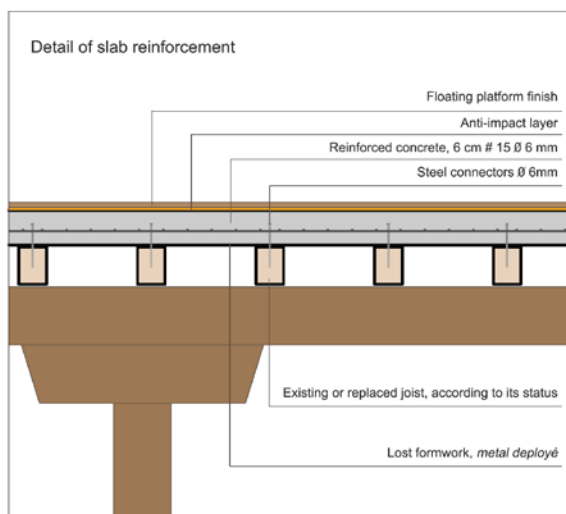
Figure 3: Detail of the reinforcement of the floors.

Regarding the state of the structure and the technical and economic feasibility of its rehabilitation, it was recommended to carry out local repair operations of the parts with damages and constructive problems, and a generalized reinforcement of the floors with a concrete slab, lightly steel reinforced and mechanically connected to the timber structure (Figure 3: and Figure 4: ).

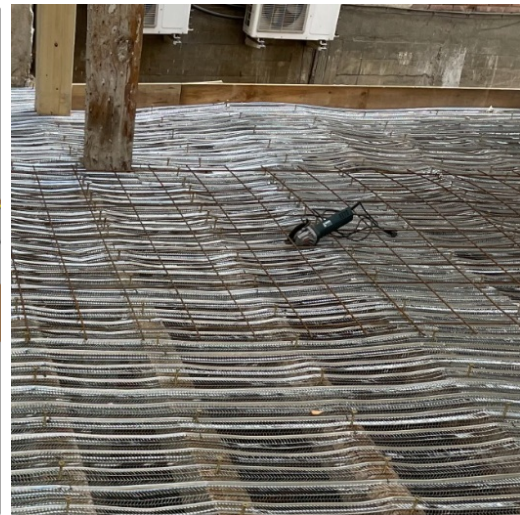
Figure 4: Laying of the mixed floor slab.

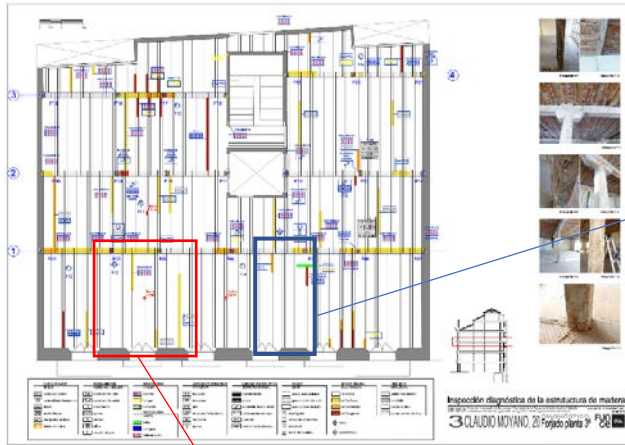
The results of visual inspection and non-destructive testing were included in a complete report and were plotted on the drawings provided by the client, following the Spanish UNE 41808 standard [4]. As an example, one of the floors of the building is shown below. (Figure 5: ):

Figure 5: Diagnosis of pathology and test areas.

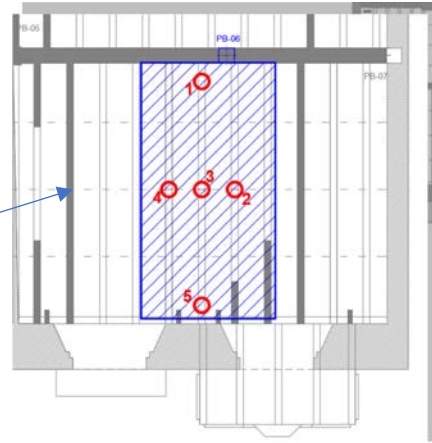
Figure 6: Static load test area.

The maximum strain values (between 1.16 and 1.35 mm) obtained in the load test are below the limit value prescribed by the Spanish Structural Code [6] for this type of structures. In addition, the maximum strain value obtained in the test is lower than the theoretical one, which can be estimated according to the mechanical characteristics of the materials that make up the floor slab and the general theory of structures. Finally, when the structure was unloaded, recoveries above the initial situation (negative) were obtained at some points

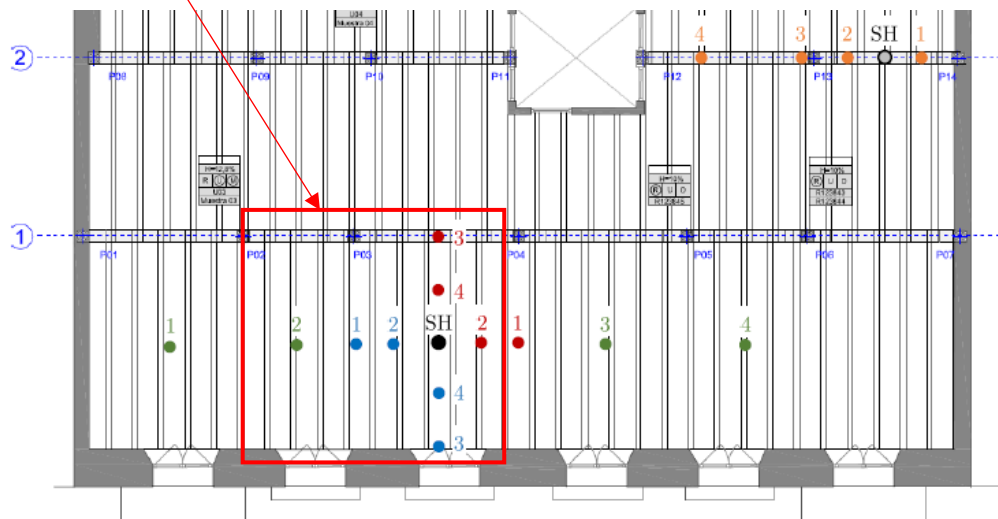
Figure 7: Dynamic test area.

The area shown in Figure 7: was instrumented with accelerometers distributed in 12 points throughout the span in 3 set-ups, adding 2 more common accelerometers located in the fixed and mobile part of the shaker. After an upward sweep from 1 Hz to 20 Hz, lasting 120 s, and the corresponding downward sweep, all recorded at 400 S/s, the frequency response functions were calculated and the modal parameters (including modal shapes, eigenfrequencies and modal damping) were extracted. As a result, after the modal identification, it was estimated that the liveliest and most relevant mode of the timber floor was the bending vertical one, at 8.97 Hz, with a damping ratio of 4.6%. This is valuable information from which derive an updated computational model.
